# Manhole Inspection Summary

Manhole # S17Y\_\_002MH

Insp Date: **6/4/08 12:59 PM**

**Location** Address: **1707 harman av**

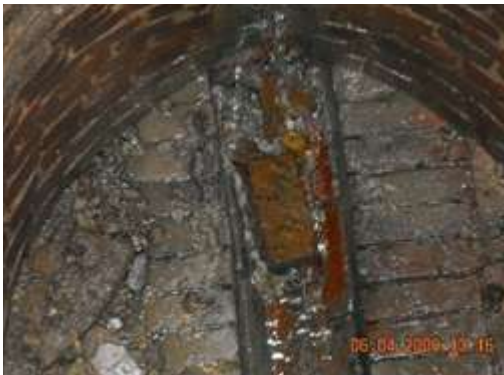
Defect 4

Condition: ☐ Sound ☐ Cracked ☐ Root Intrusion ☐ Deteriorated ☐ Leaks ☒ **Debris**

debris in channel

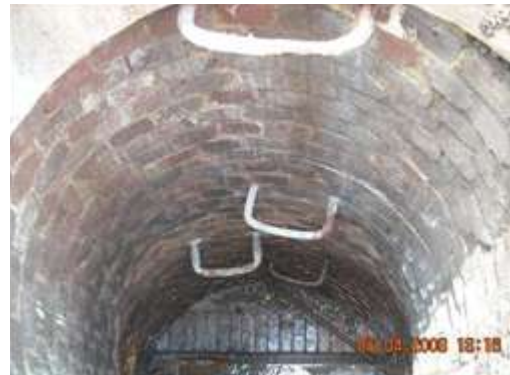
Defect 3

**Steps** Count: **4** Missing: **1** ☒ **Corroded**

corroded & missing steps, bench debris

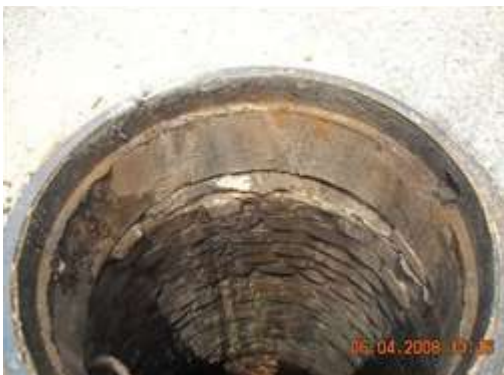
Defect 2

Infiltration: ☐ None ☒ **Joint** ☐ Cracks ☐ Mortar ☐ Roots ☐ Wall

Infiltration @ corbel/frame joint; inflow evidence from sheeting

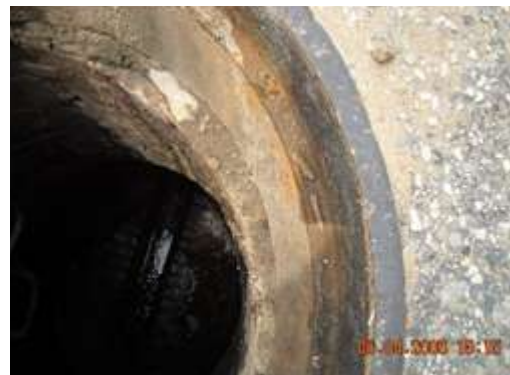
Defect 1

**Frame** Offset: **1** (in.) Condition: ☐ Sound ☐ Cracked ☒ **Leaks**

frame offset

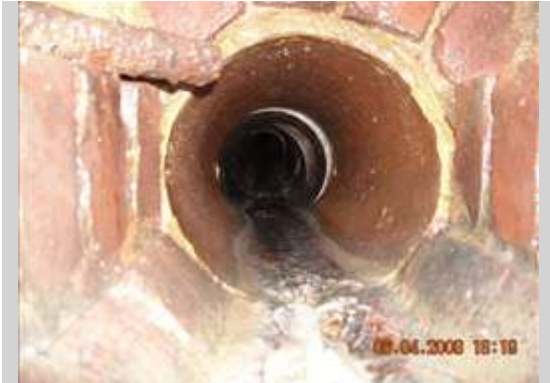
12 O'Clock Outflow

8 in. Circular Gravity Sewer  
Pipe Out @ 12 O'Clock

Pipe Height: **8.4** (in.) Rod and Bar (Angled)  
Pipe Material: **Clay** ☐ Pipe Lined  
Invert Depth: **9.00** (ft.) Flow Characteristics: **Slow**  
Deposits: ☒ None ☐ Mud ☐ Sludge ☐ **Debris** ☐ Grease  
Silt Depth: **0** (in.) Deposits Extent:  
Infiltration: **None** Pipe Seal Cond: **Sound**

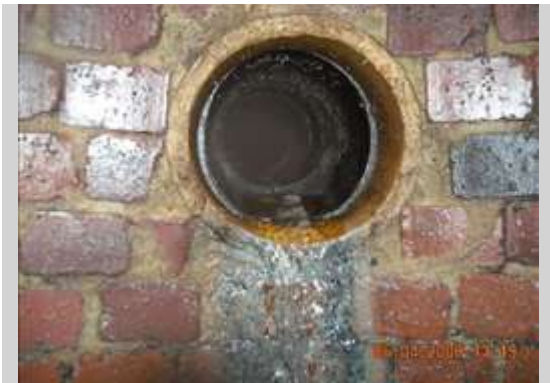
6 O'Clock Inflow

8 in. Circular Gravity Sewer  
Pipe In @ 6 O'Clock

Pipe Height: **8.4** (in.) Rod and Bar (Angled)  
Pipe Material: **Clay** ☐ Pipe Lined  
Invert Depth: **7.30** (ft.) Flow Characteristics: **Slow**  
Deposits: ☐ None ☐ Mud ☐ Sludge ☒ **Debris** ☐ Grease  
Silt Depth: **8** (in.) Deposits Extent: **Heavy**  
Infiltration: **None** Pipe Seal Cond: **Unknown**

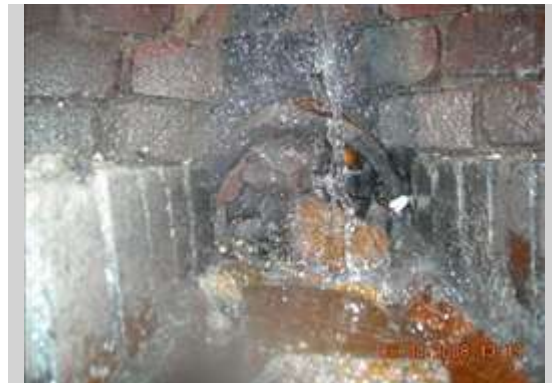
Drop In @ 6 O'Clock

Drop: **Outside** Rod and Bar  
Angled: **Yes** Reading: **7.80** (ft.)  
Inv Depth: **8.80** (ft.)  
Drop Condition: **Clogged**
